Refit

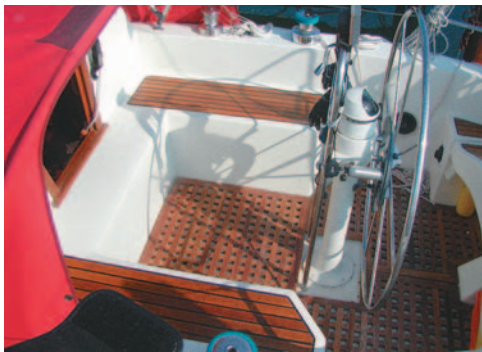
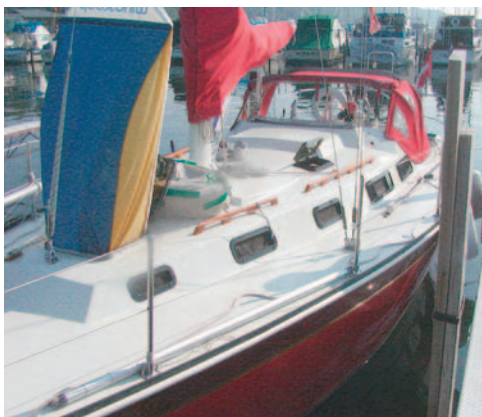
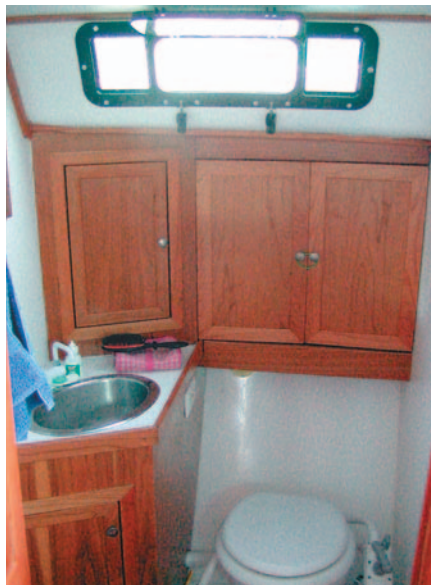
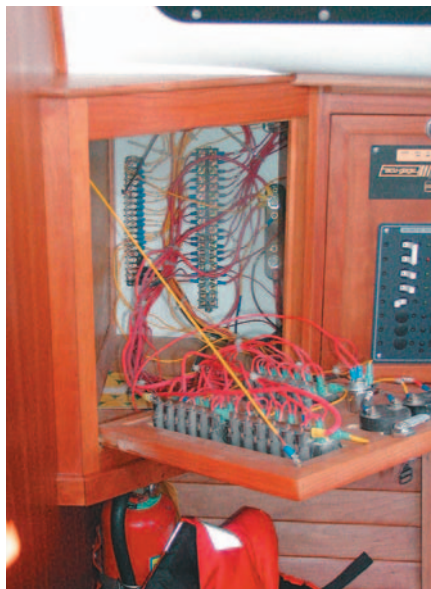
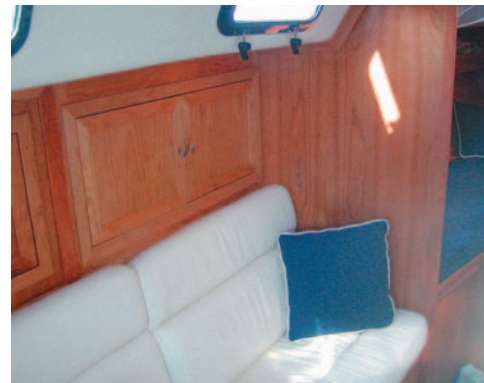
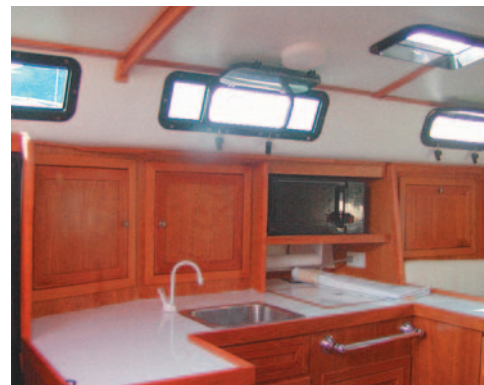
Images at left: the completed cockpit and the completed deck. In the center: the completely rebuilt head and the power panels. At right: the saloon and the galley.
