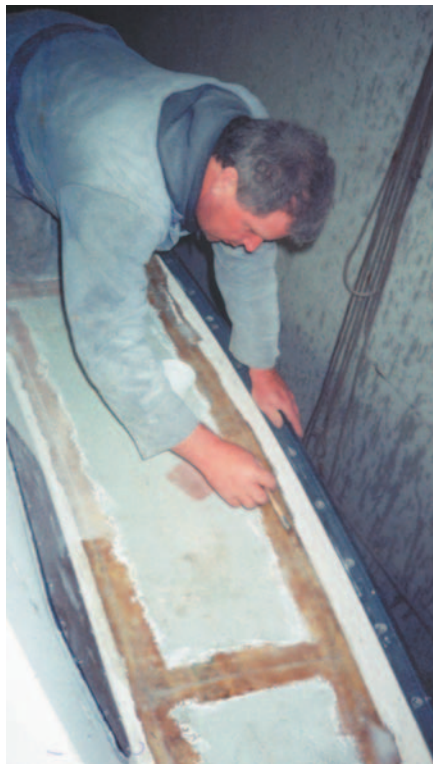
— before it caved in — was the delaminated balsa core deck. Dave decided to leave the interior in place to support the deck shape while they worked on it. He removed all deck hardware and fittings: cleats, turning blocks, ports, everything. To preserve the original shape of the deck, Dave and Joe cut the outer skin off the deck in sections.

Dave was amazed at how thin the skins were. He later learned the engineering principle of a cored structure that uses thin skins over a lightweight core to increase stiffness without creating excessive weight. As suspected, the core was wet and, in many areas, rotted. Much of it was literally wood pulp that could be cleared away with a putty knife and wire brush. A portable router with a bit set to the thickness of the core cleanly removed the remaining balsa wood.

Dave MacMillan bonds the deck skins back together, above, after the top skin was vacuum-bagged in place. Other views at right from top: the balsa core is vacuum-bagged; Diane MacMillan wet-sands the deck between layers of paint; the bow during painting; the cockpit at a similar stage; and Diane does finish work on the cherry tongue-and-groove planking which lines the hull.

They set about rebuilding the deck. Section by section, they sanded the inner skin and troweled on a layer of filled epoxy. They pressed new end-grain balsa core in place and vacuum-bagged it using a small medical vacuum pump and clear film. The film allowed them to see the epoxy flow through the core as the vacuum pressed it tightly to the inner skin.

After a section of impregnated core hardened, they sanded it, troweled another layer of filled epoxy over the core, and set the outer deck skin back in place. The vacuum was again applied to clamp the outer skin in place. They repeated this process until the entire deck was re-cored. As they progressed, they filled all the holes in the deck, including the old portholes. They added solid reinforcements where deck hardware would be placed. They also added ABS plastic core for a pair of genoa tracks.
